Cap Inspection Report for the Former Pacific Electric Motors Facility, 1009 66th Avenue, Oakland, California

This letter documents the condition of the cap located at the Site based on the inspection that was conducted by Mr. Wayne Hung of ARCADIS on January 17, 2015. During the inspection, the surface of the cap was visually inspected and photographed for the following criteria:

February 2, 2015

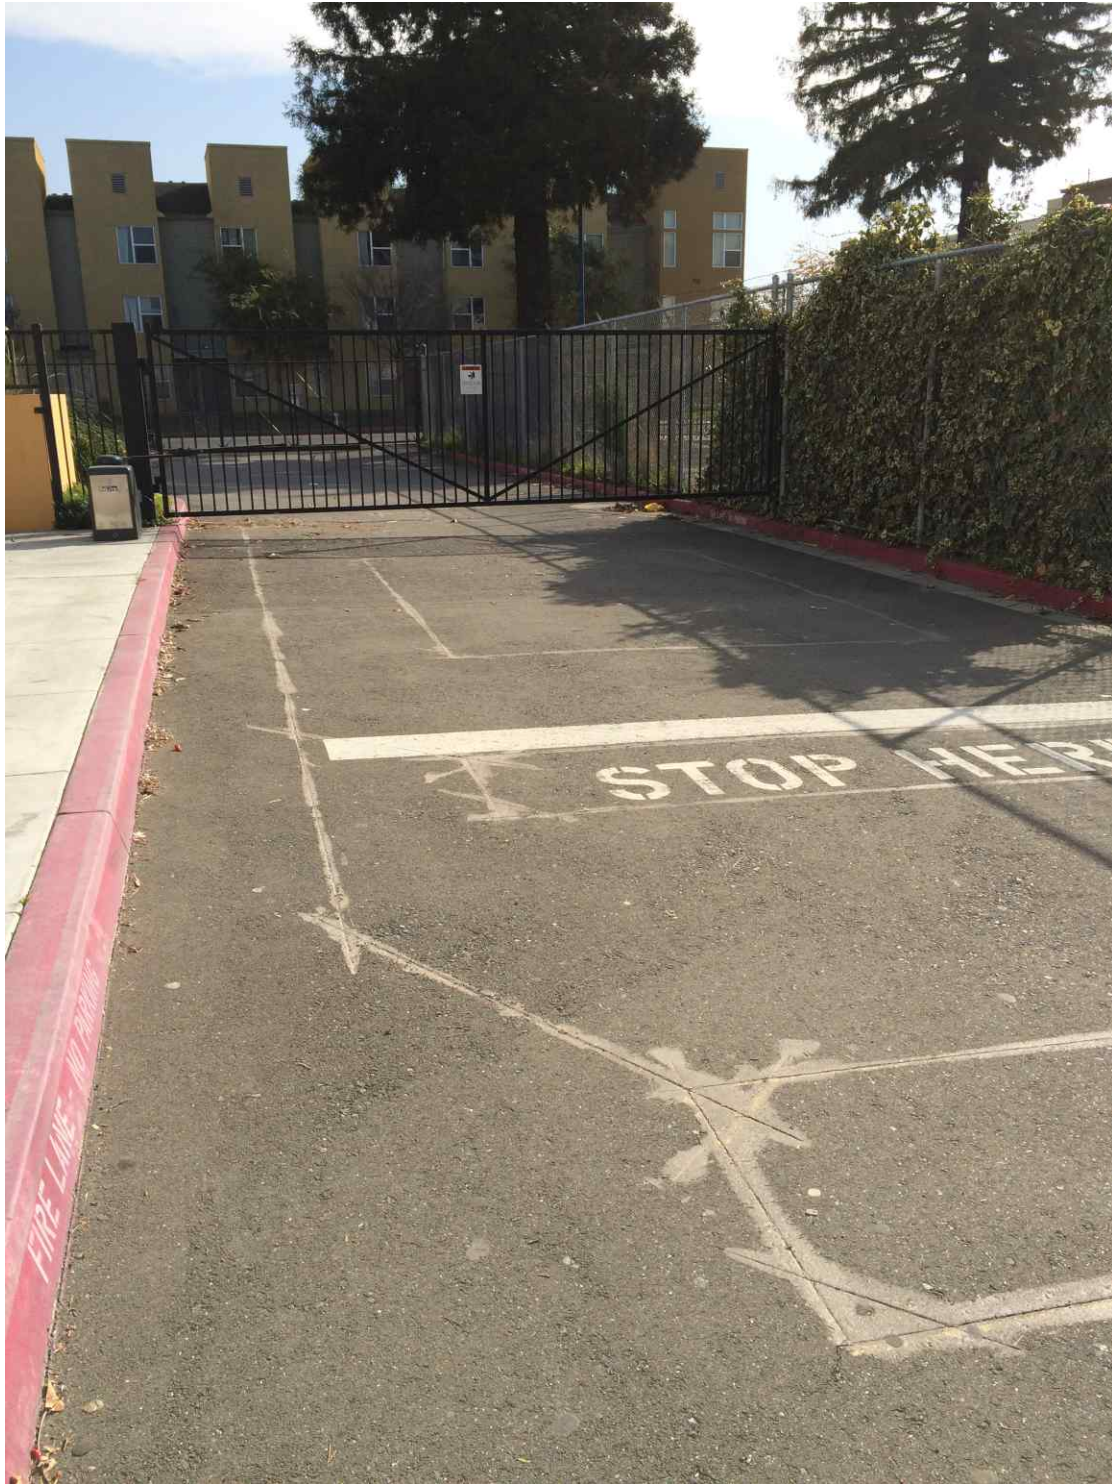
FIGURE
B-1

Vehicle Traffic Area Looking Southwest Towards 66th Avenue

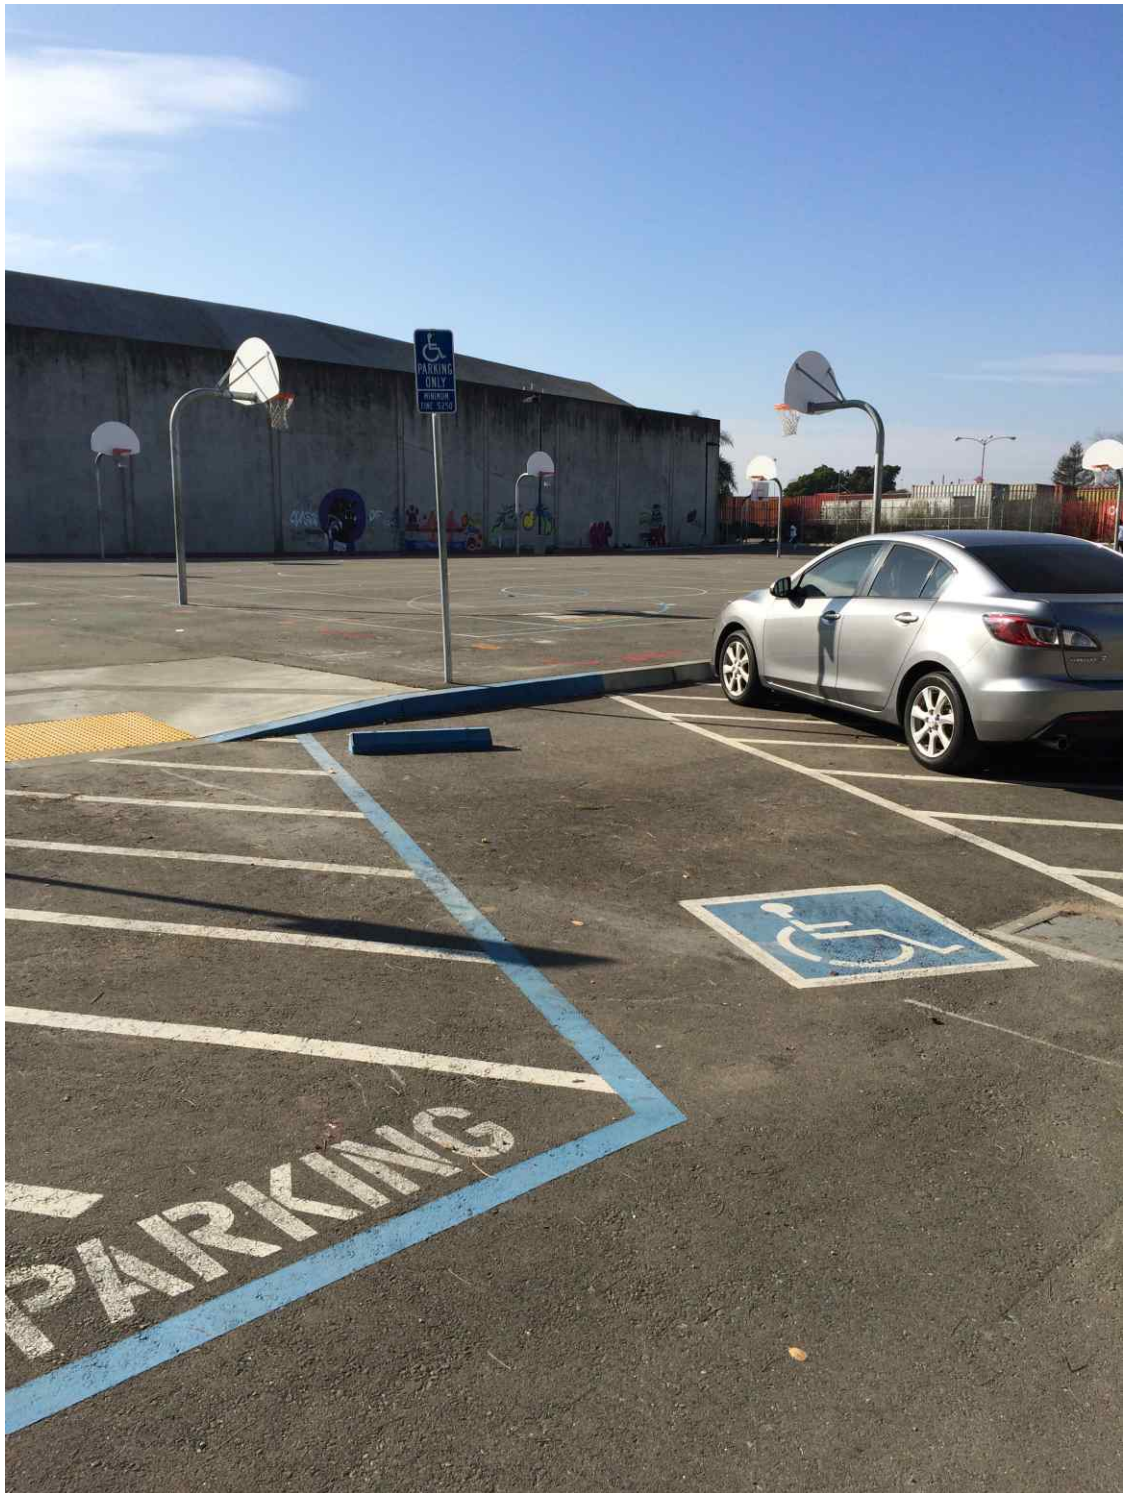
FIGURE
B-2

Vehicle Traffic Area looking north

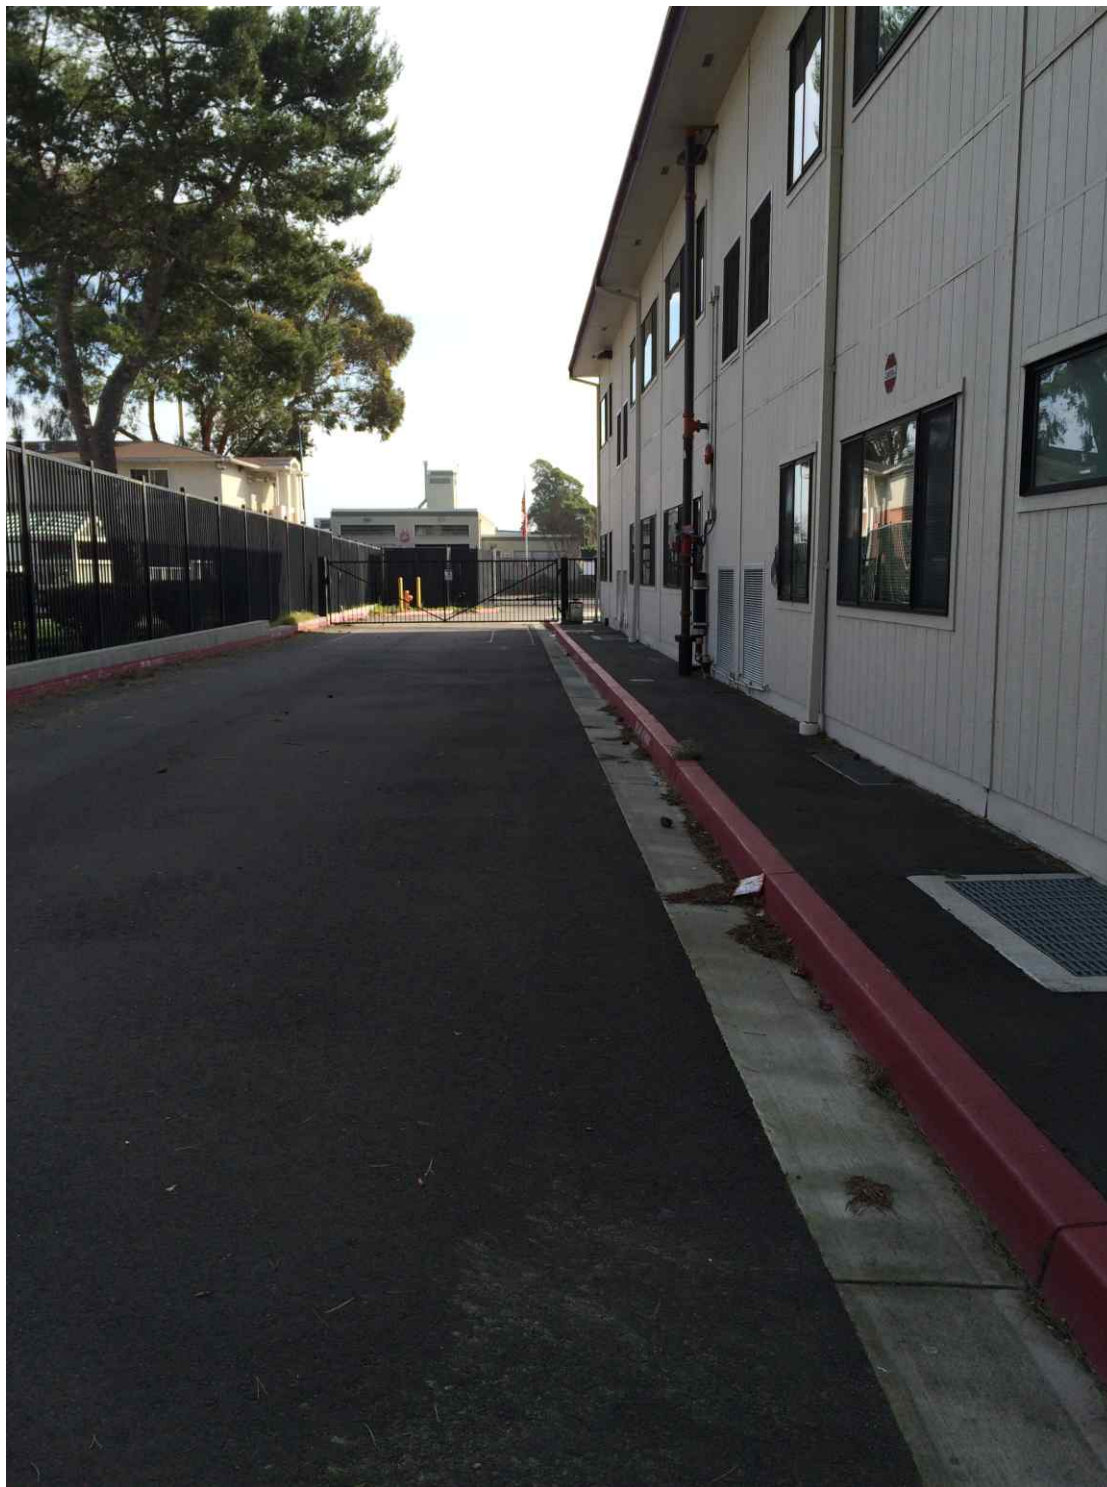
FIGURE
B-3

Vehicle Traffic Area Adjacent to Classroom on East Side of the Site-
looking towards 66th Avenue

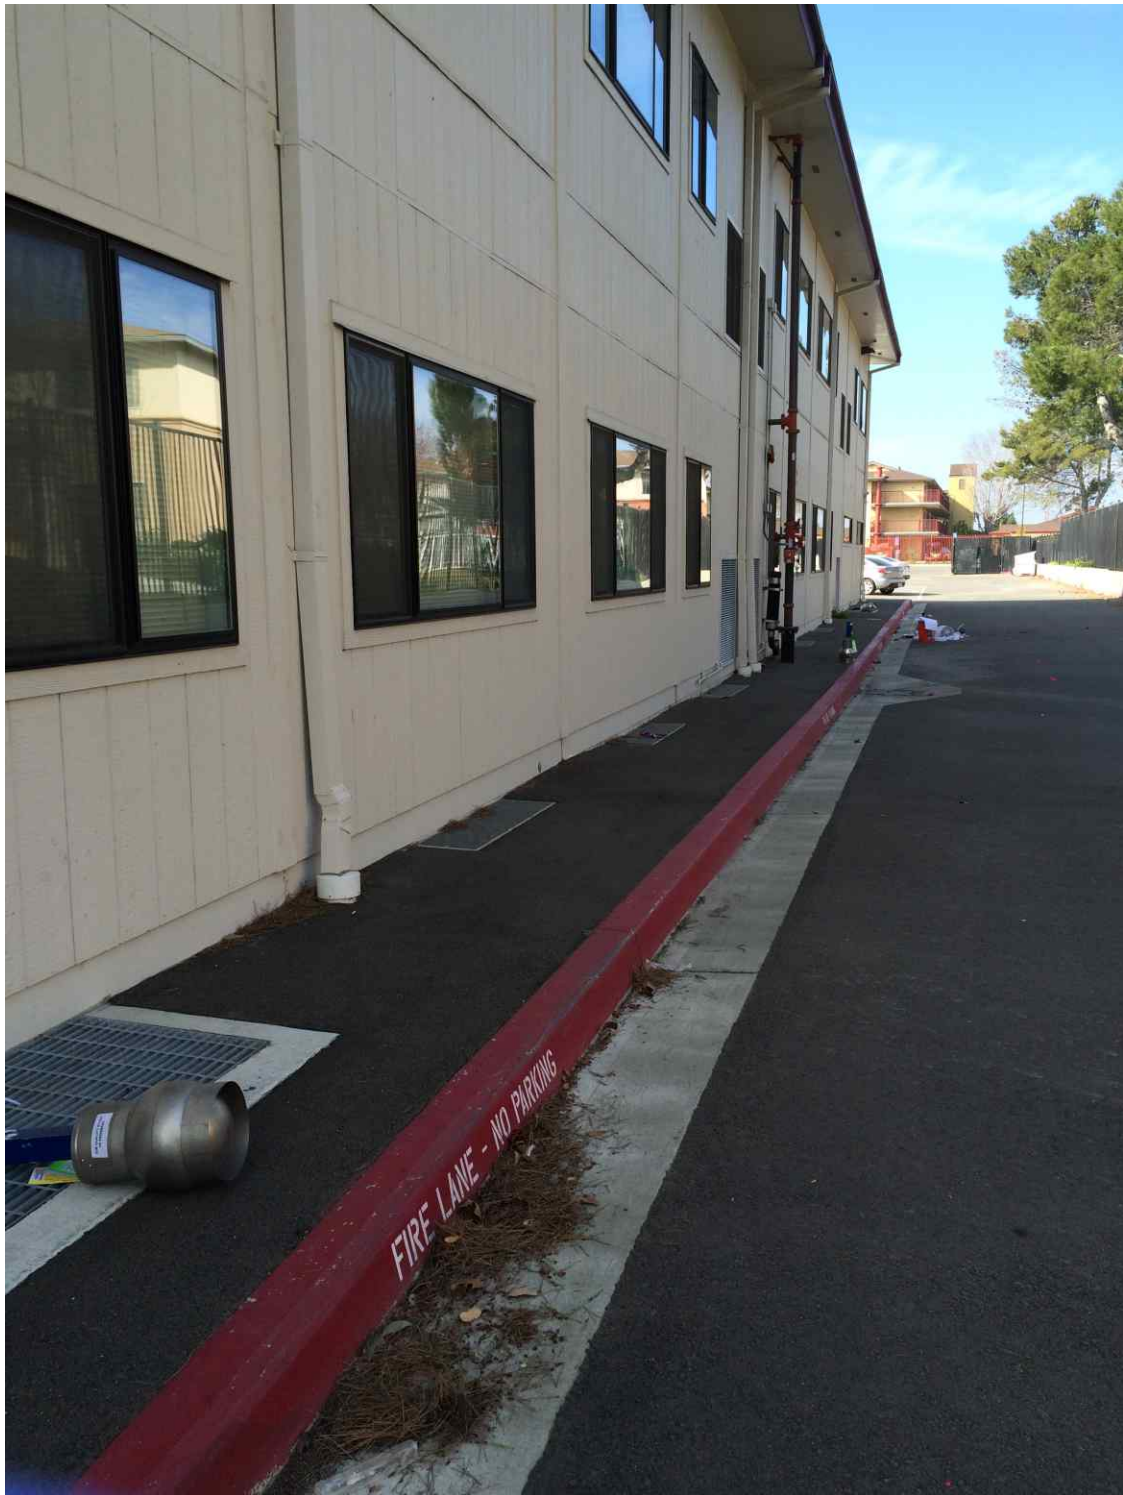
FIGURE
B-4

Vehicle Traffic Area Adjacent to Classroom on East Side of the Site

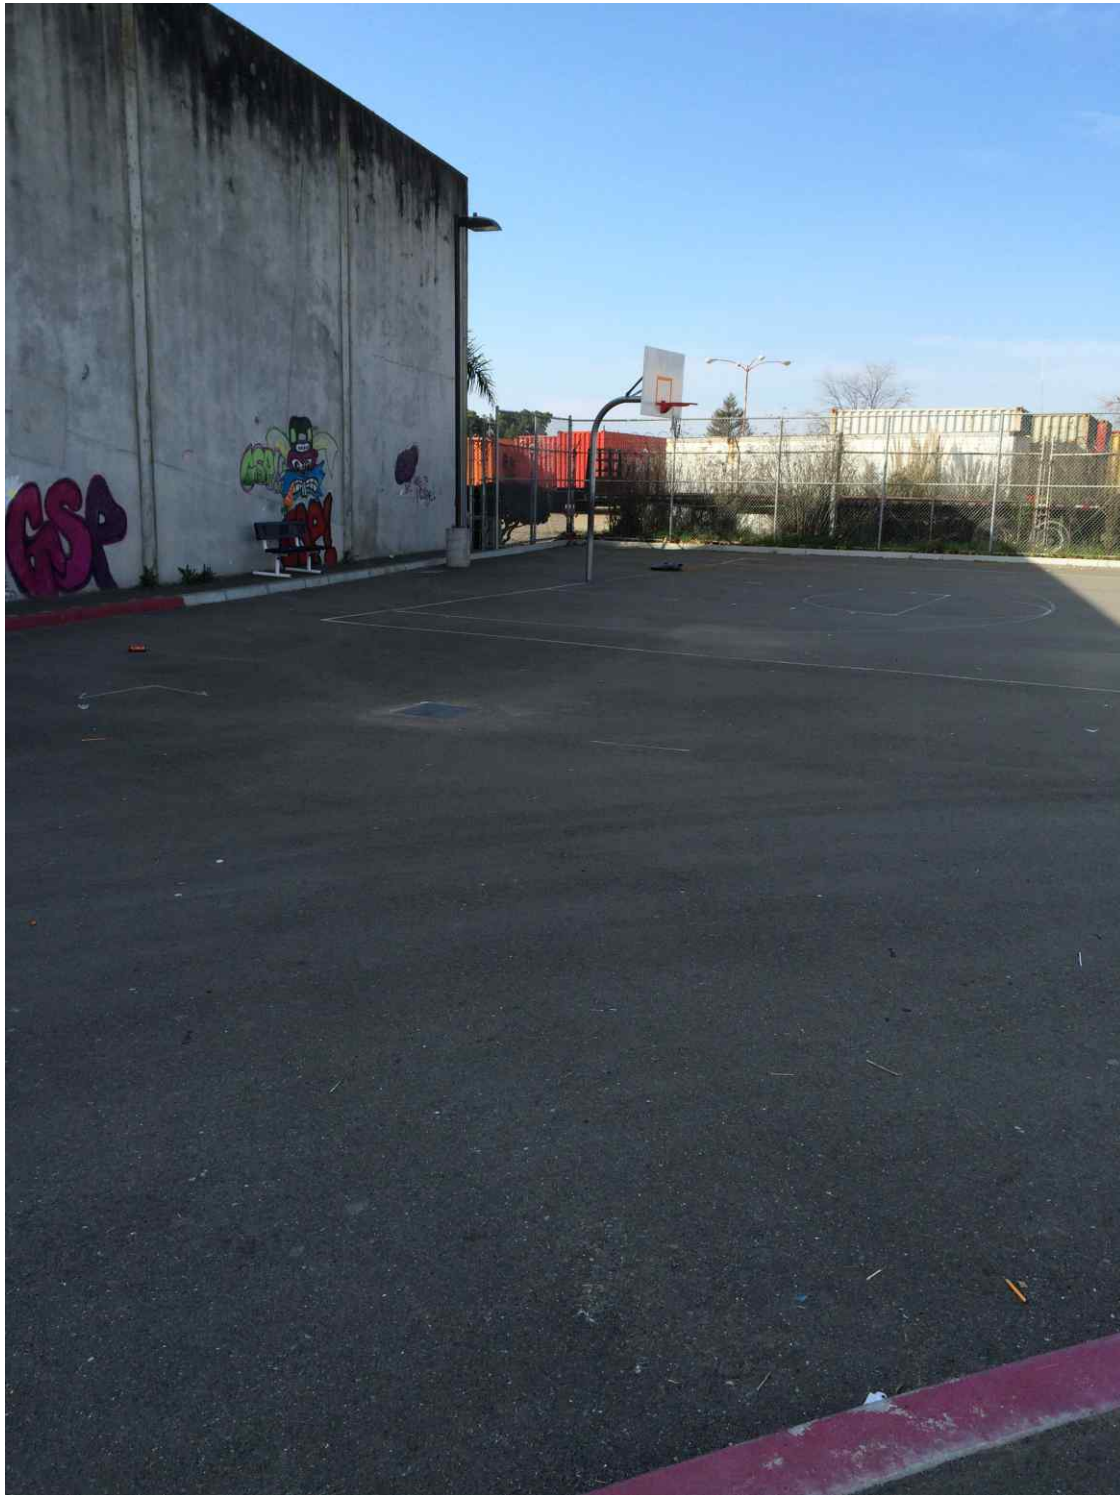
FIGURE
B-5

Vehicle Traffic Area Near Looking North

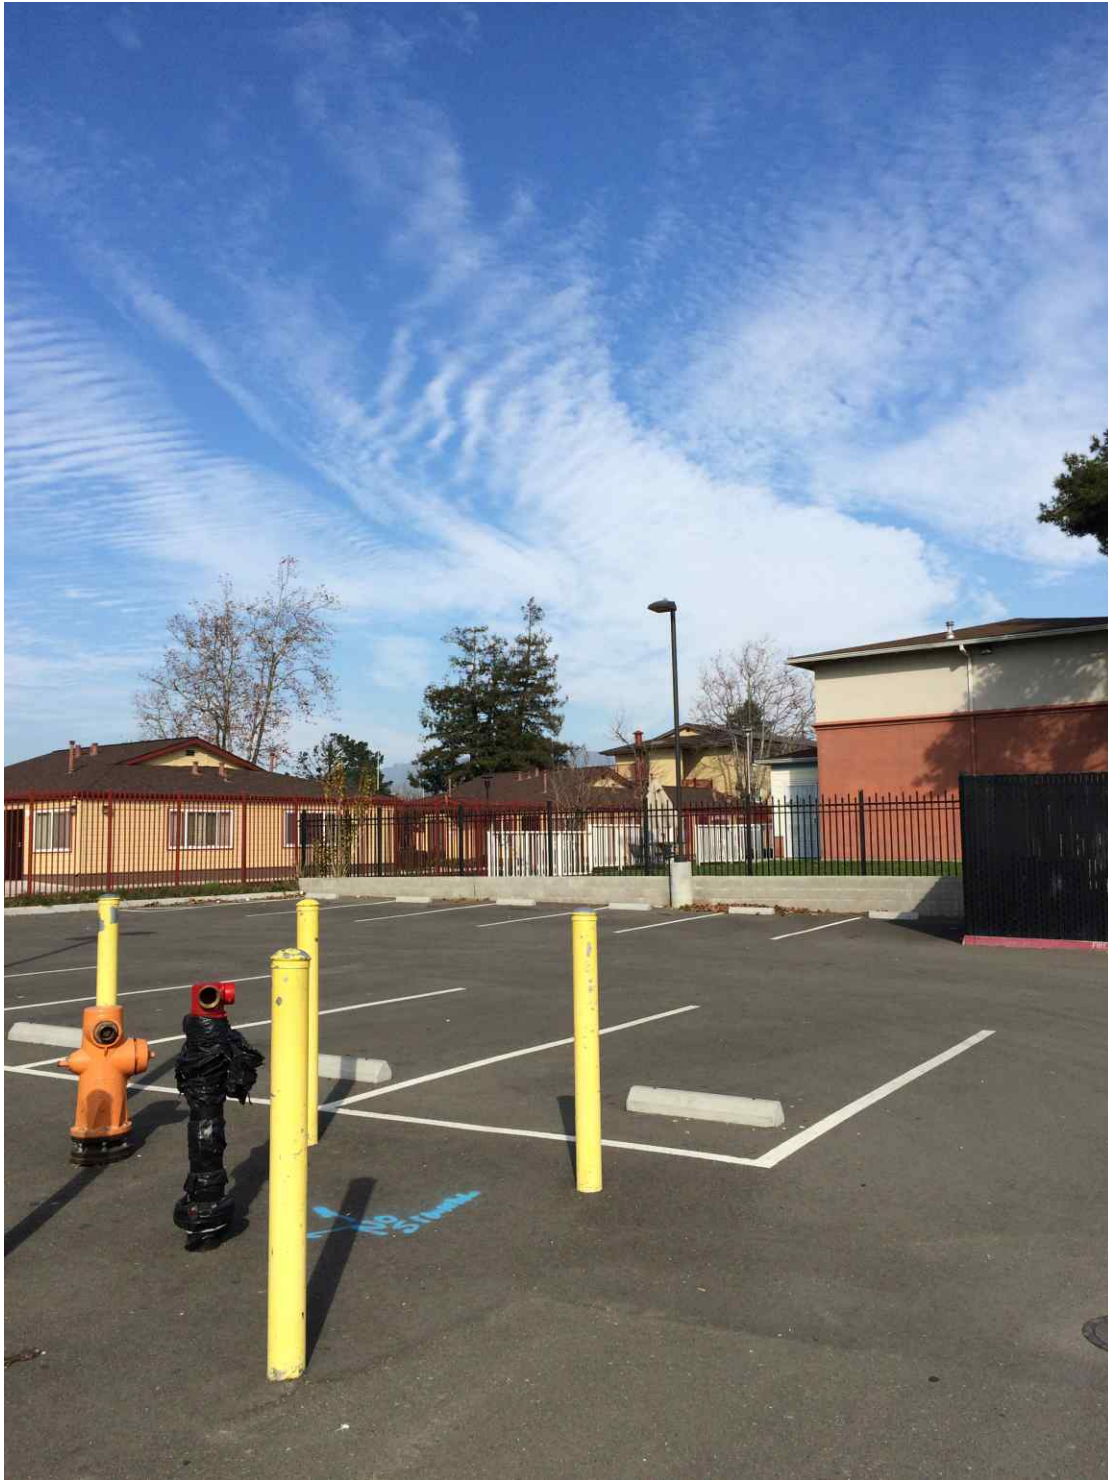
FIGURE
B-6

Vehicle Traffic Area Near Looking Northeast

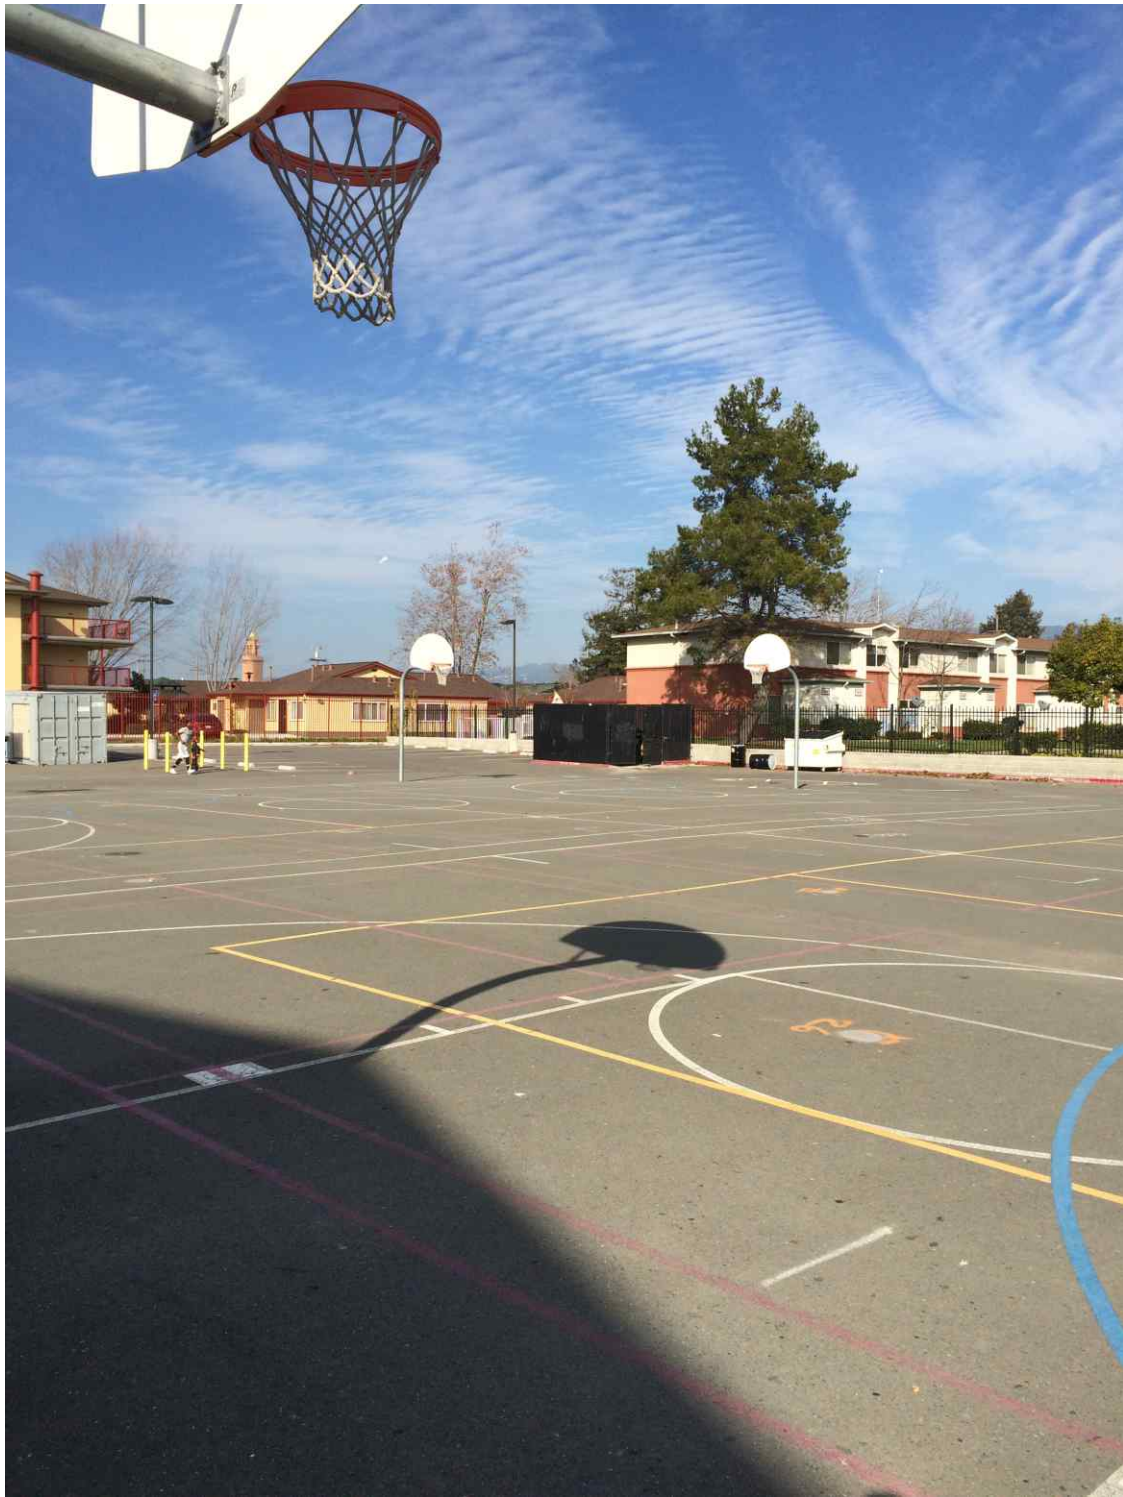
FIGURE
B-7

Vehicle Traffic Area Near the Rear of the Site

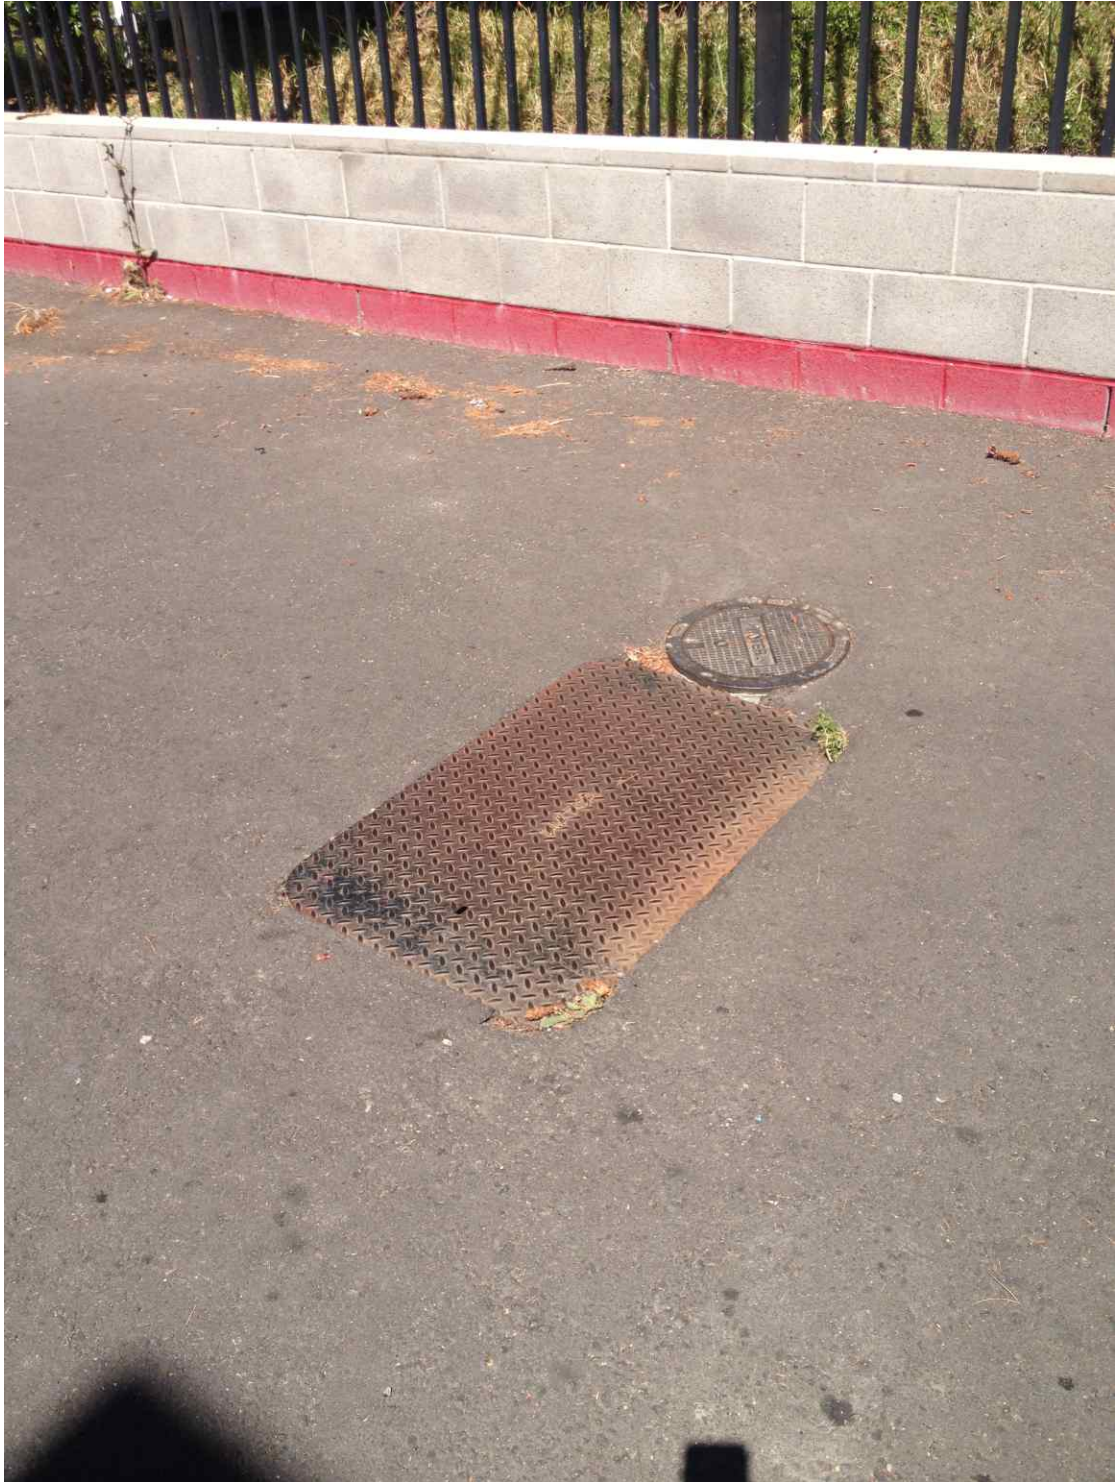
FIGURE
B-8

Utilitiy Vault in the Vehicle Traffic Area

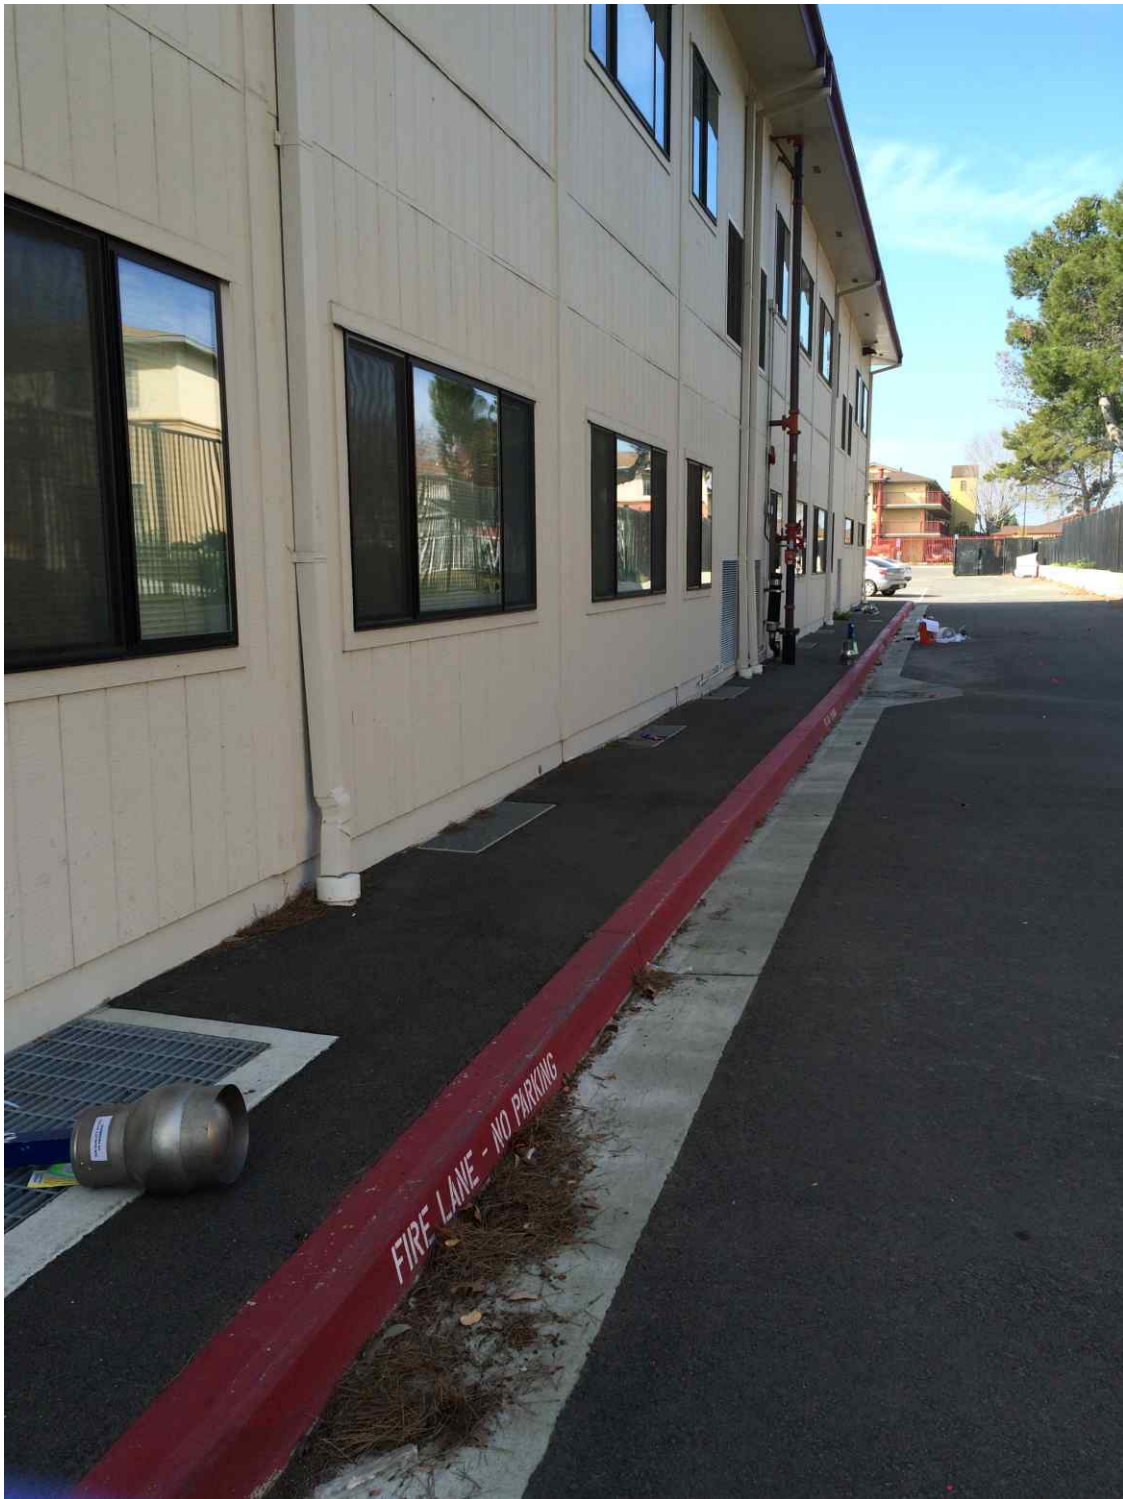
FIGURE
B-9

Vehicle Traffic Area Adjacent to Classroom on East Side of the Site

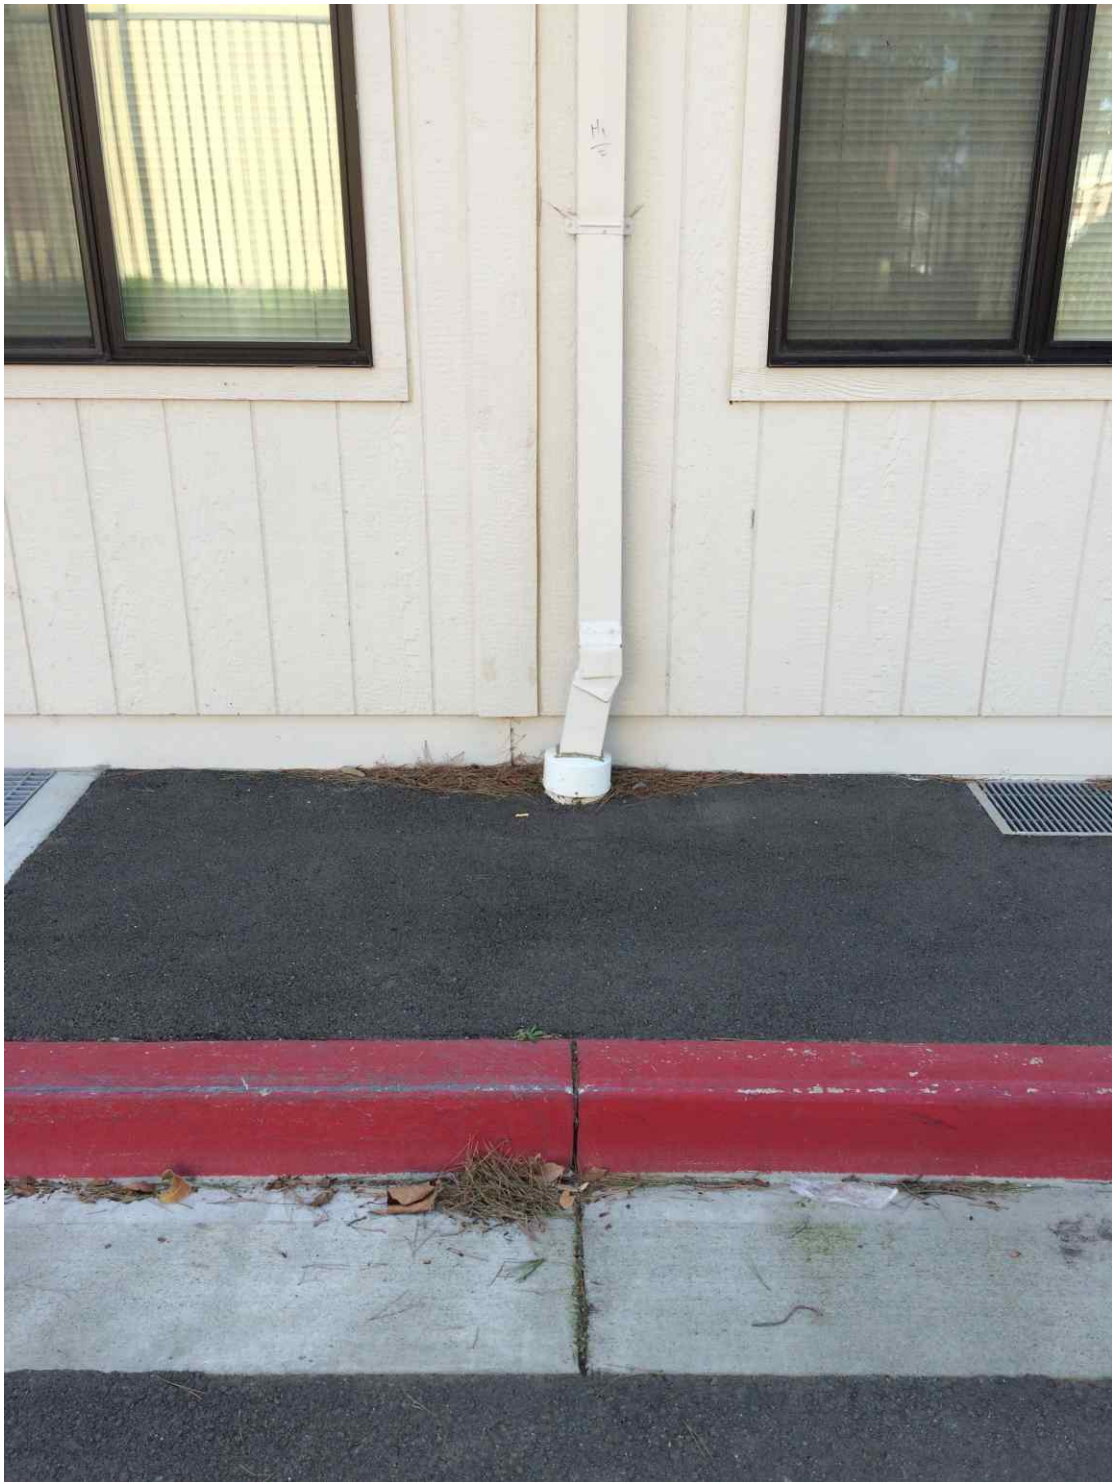
FIGURE
B-10

hardscaped Area Adjacent to Classroom

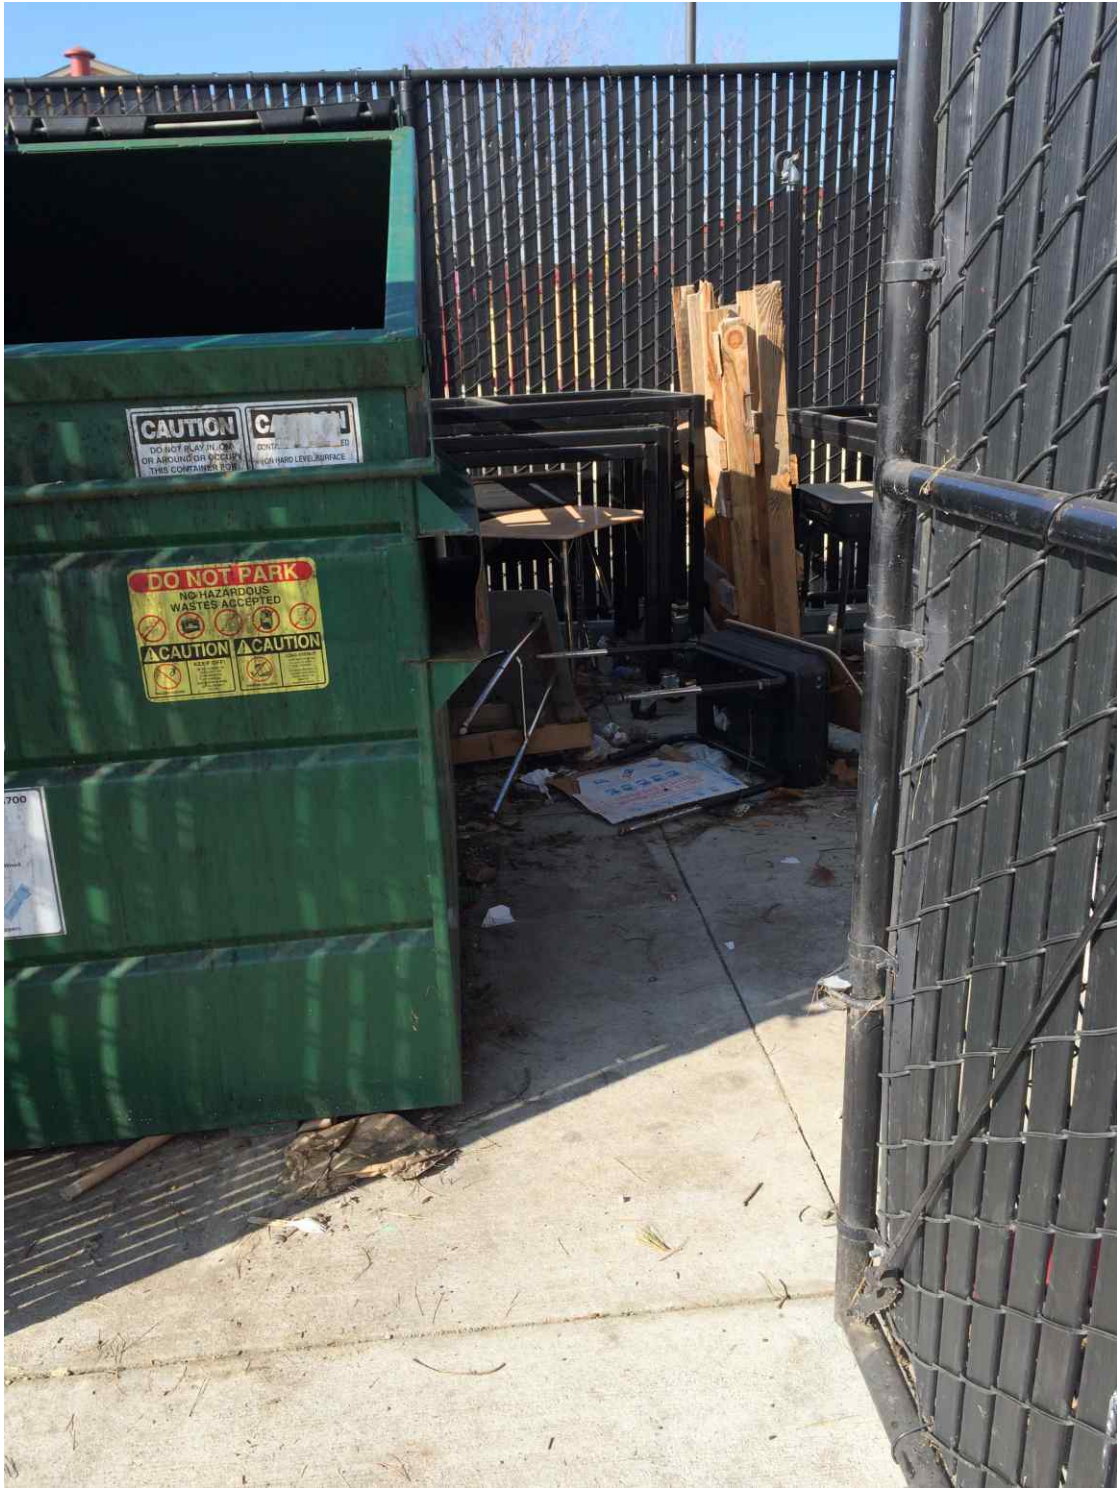
FIGURE
B-11

Trash Enclosure Area

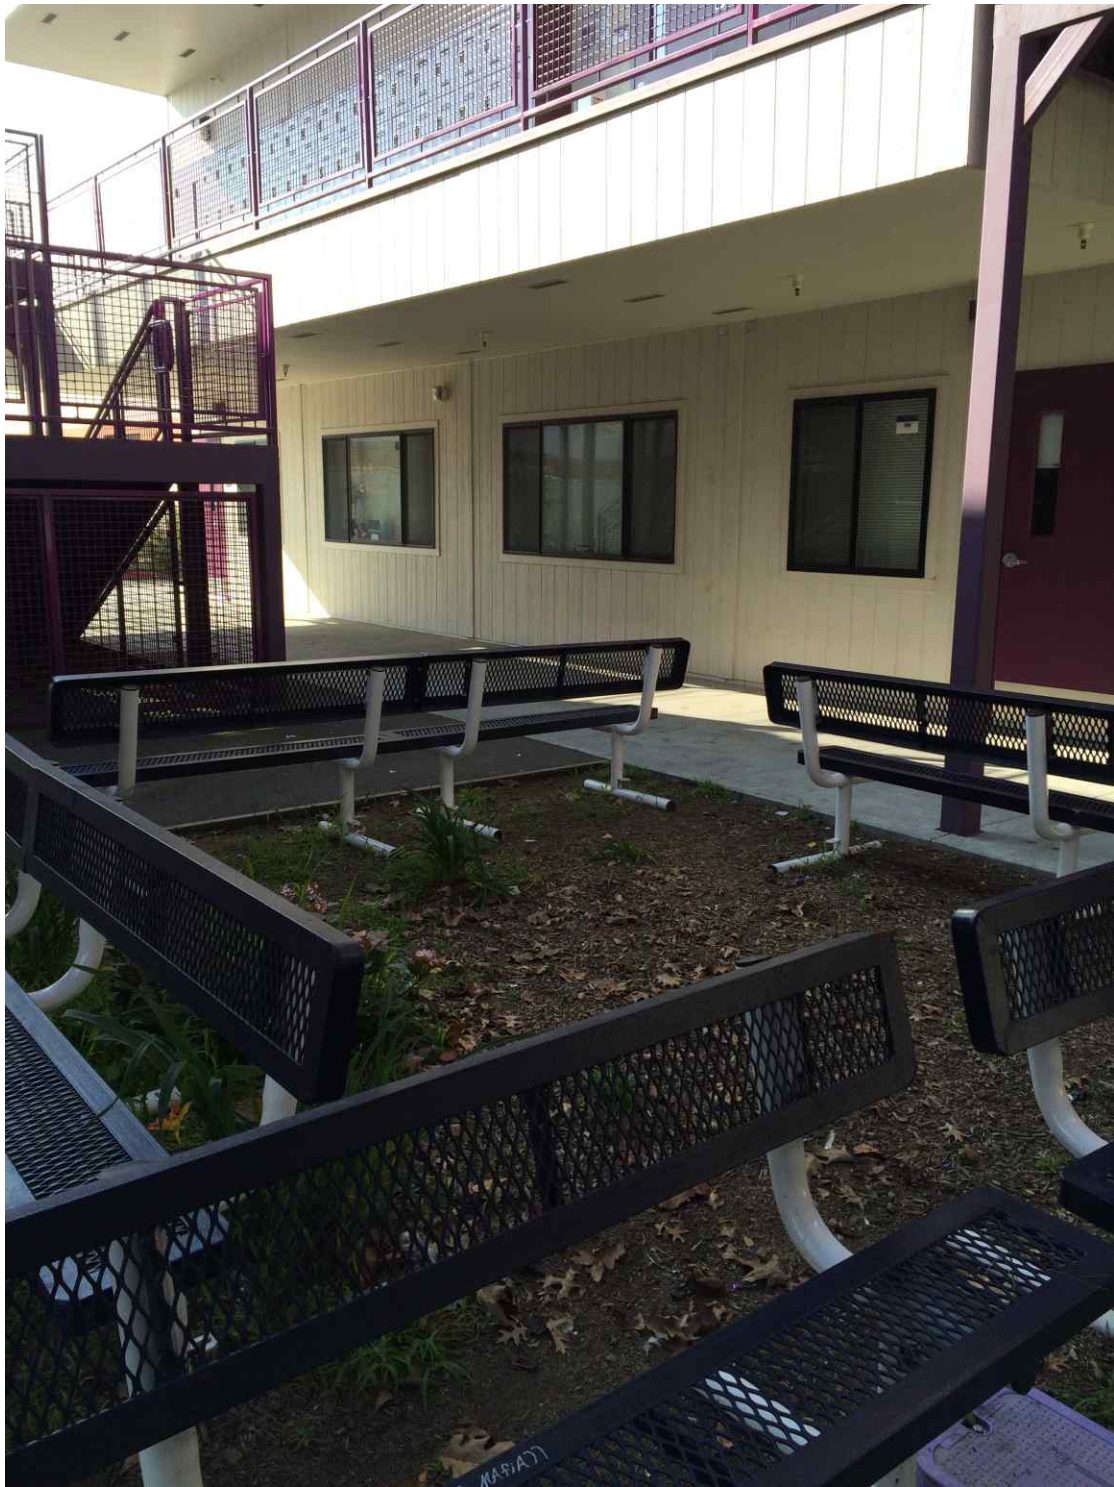
FIGURE
B-12

Landscaped Area in the Pedestrian Walkway - Courtyard Area

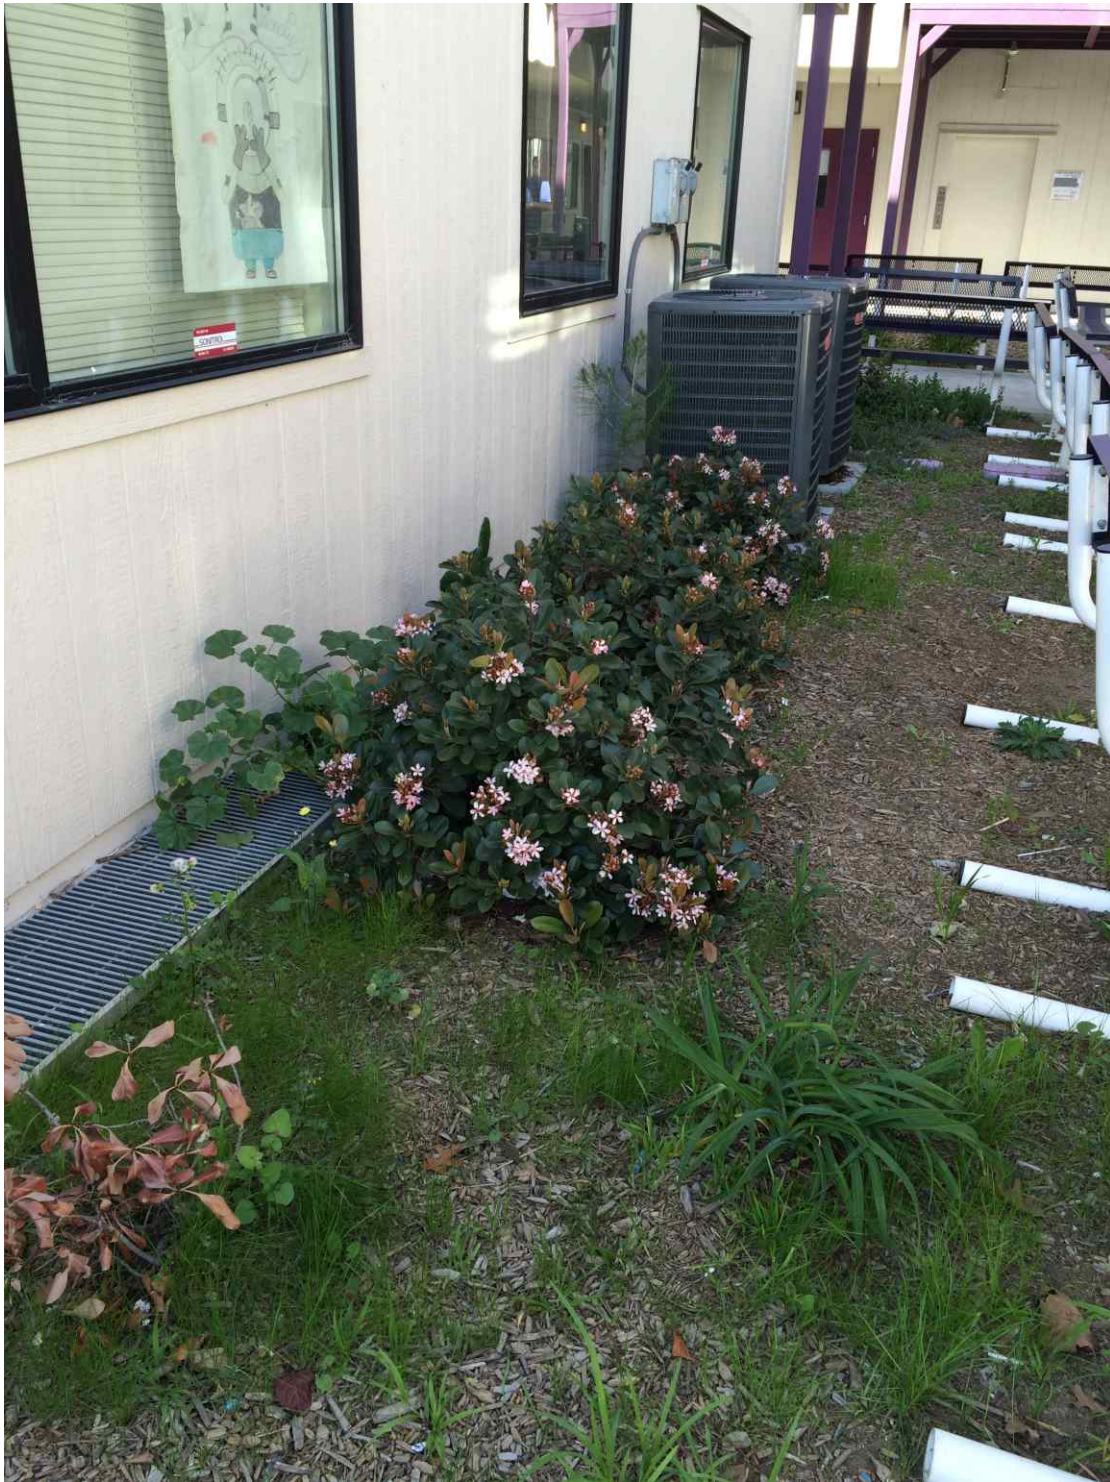
FIGURE
B-13

Landscaped Area in the Pedestrian Walkway - Courtyard Area-1
